APPENDIX C

Abandoned, Vacant, Underutilized, and Potential
Brownfield Sites

Wyandanch Downtown Revitalization Plan

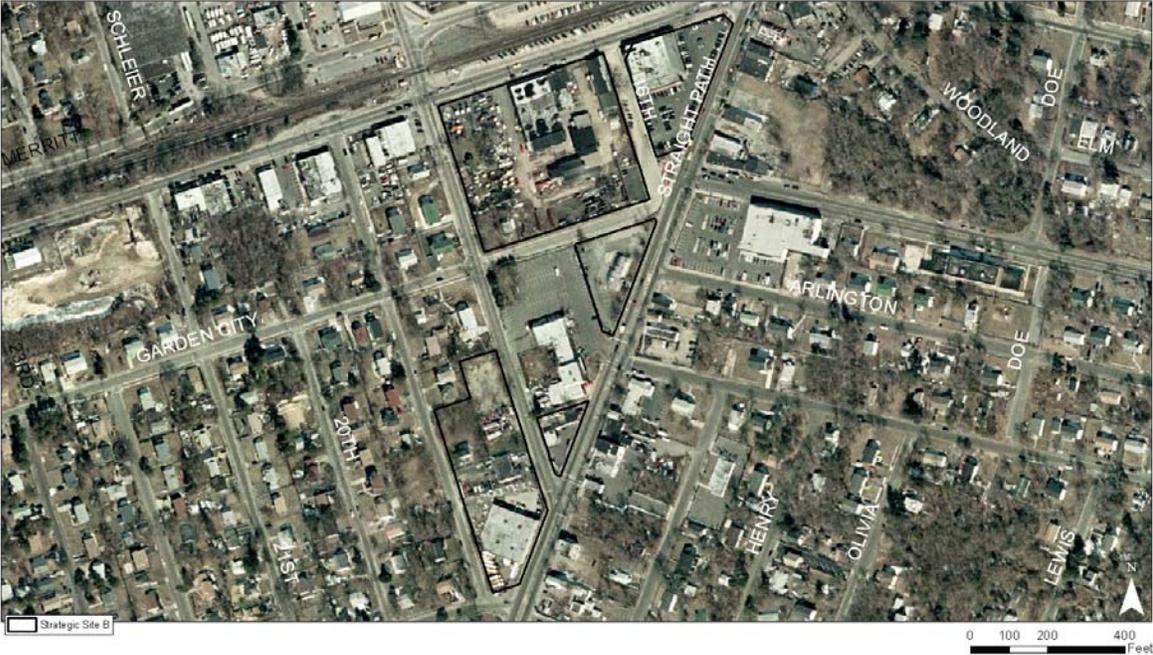
Digital Photo of Property

This site, totaling approximately 8.79 acres, includes multiple parcels fronting on the west side of Straight Path south of Long Island Avenue, including the Martin Luther King Jr. Community Health Center, a vacant Kentucky Fried Chicken, and smaller retail uses. Behind those lots between S. 16th and S. 18th Streets is the Weld Built Body Co. Inc.—an industrial use—and several residences owned by Weld Built. On the lots between S. 18th and S. 19th Streets are two auto repair lots, a bus storage lot, and several vacant parcels, as well as one residence in poor condition.

Overall, the site has limited environmental concerns. However, lot 56-3-44.1, an auto repair, has a closed status spill and is a RCRA hazardous waste generator. Lot 56-3-73 is an industrial use with petroleum storage tanks, a closed status spill, and is also a RCRA hazardous waste generator. Several other sites also have environmental concerns related to petroleum storage tanks. (See Table 1 for a summary of environmental conditions on each of the site's individual lots.)

Site B is an important potential redevelopment site, due to its proximity to the train station and presence of a building that has been vacant for nearly 20 years, in addition to blighted industrial uses.

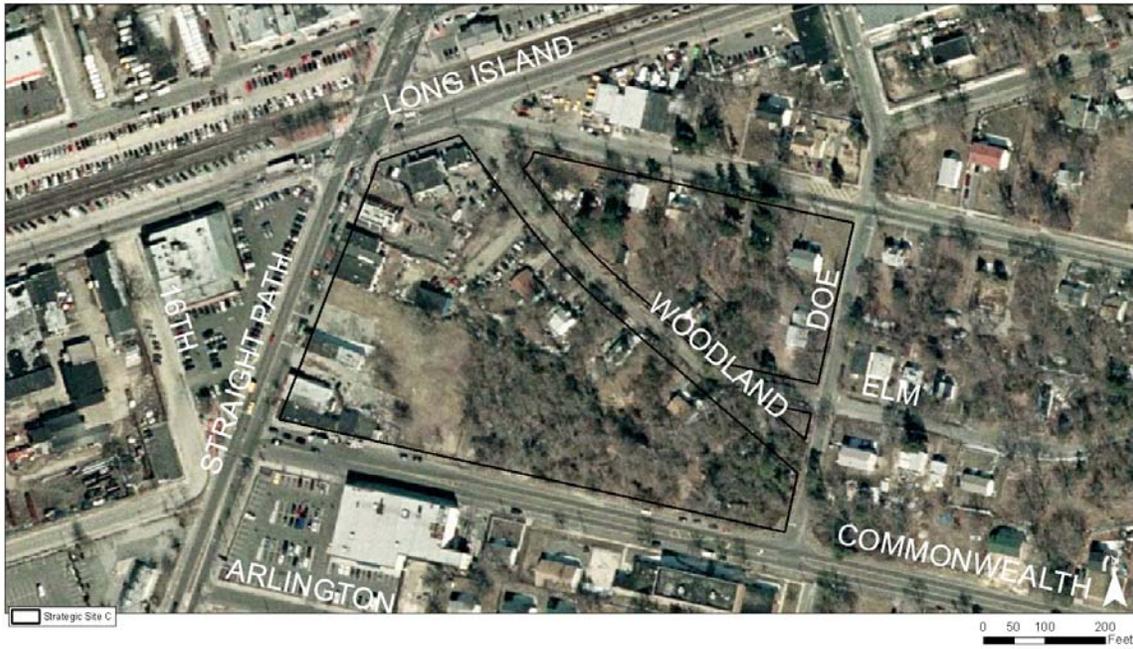
Digital Photo of Property

Historical uses of the site are unknown. Overall, the site has limited environmental concerns. However, several lots have closed status spills or are associated with industrial uses or petroleum storage tanks. Lot 57-1-33.1 has serious environmental contamination implications including auto repair use, closed petroleum storage tanks, closed status spill, and is a RCRA hazardous waste generator. (See Table 1 for a summary of environmental conditions on each of the site's individual lots.)

Site C is an important potential redevelopment site, due to its proximity to the train station, presence of long-standing vacant buildings, substantial vacant land, and presence of a new post office that could act as a catalyst for redevelopment.
